# MET ONE Particle Sensors Resistance to Vaporous Hydrogen Peroxide (VHP)

Ted Lawrence

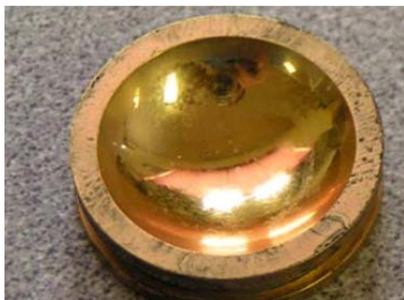
**Figure 2 - Mirror condition over time**
